# Construction chronology of bridges on I-95 SB & NB

# **Summary of Rehabilitation Recommendations**

# Maintenance of Traffic – Rehab. on I-95 bridges

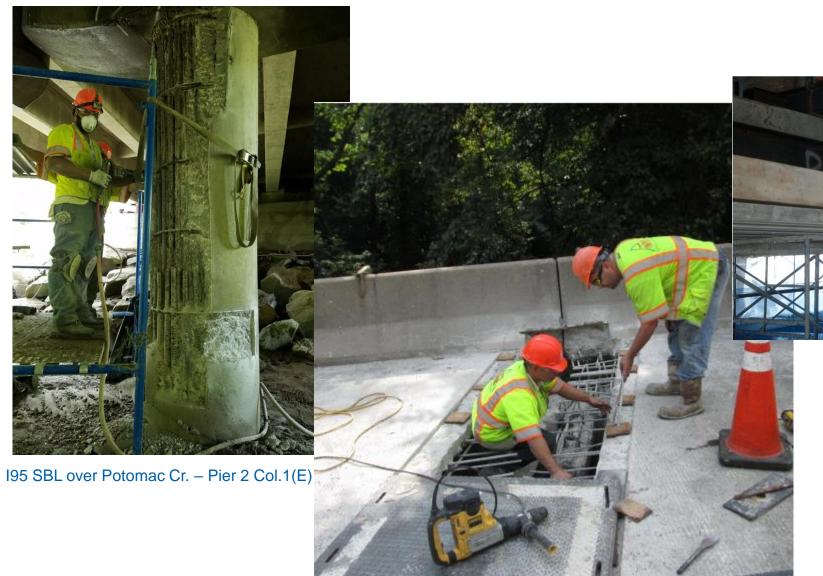
195 SBL over Ni River – Pier 2 Jacking-Blocking

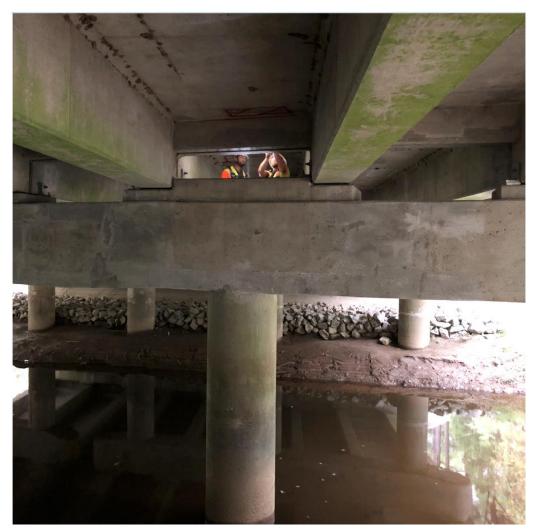
195 SBL over Ni River – Bay 6 looking North

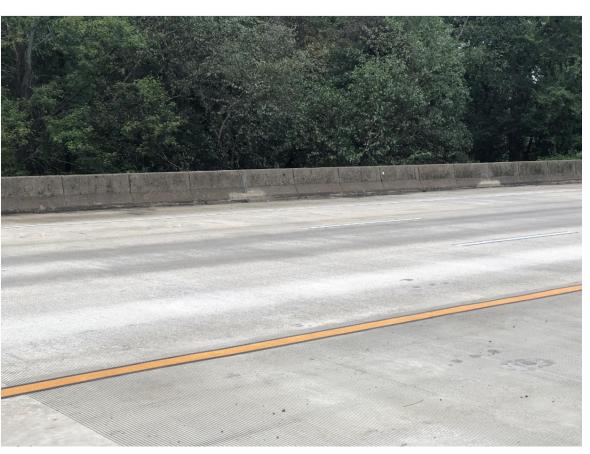
195 SBL over Ni River - Deck surface looking West

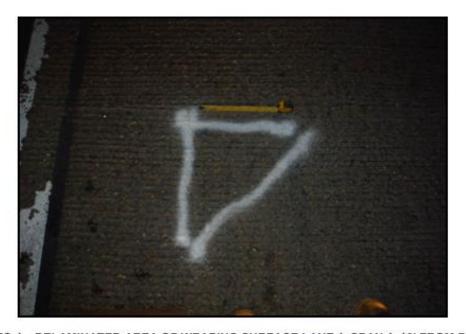
PHOTO 4 - DELAMINATED AREA OF WEARING SURFACE LANE 1, SPAN 1, 16' FROM PIER 1

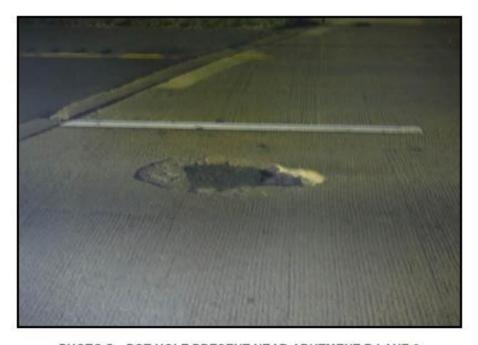
PHOTO 5 - POT HOLE PRESENT NEAR ABUTMENT B LANE 2

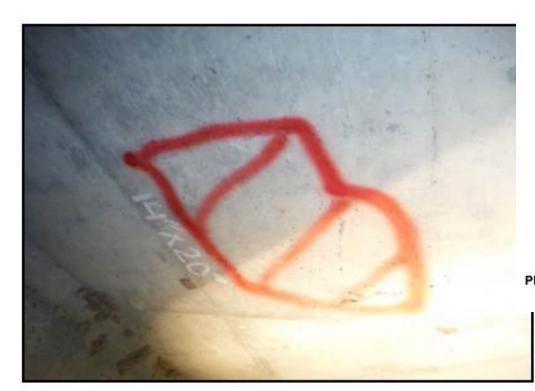
PHOTO 6 - UNDERSIDE OF DECK DELAMINATION IN SPAN 2, BAY 7 NEAR MID SPAN

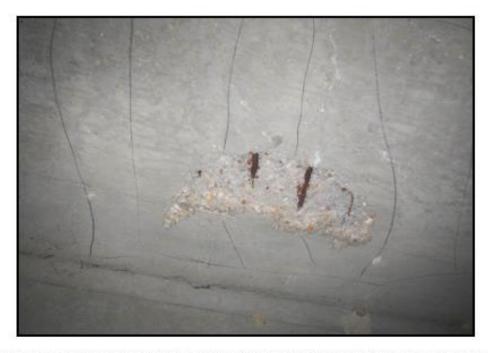
PHOTO 7 – SPALL WITH EXPOSED REBAR IN UNDERSIDE OF DECK, SPAN 3, BAY 6 NEAR ABUTMENT B, 3'L X 1'W X 4"D

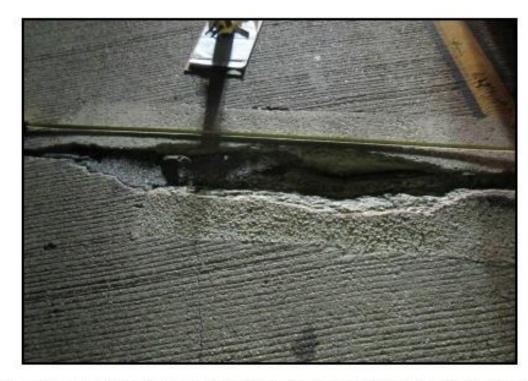
PHOTO 11 – OVER PIER 2, 12 LF OF JOINT HAS BROKEN BOND AND IS LEAKING WITH SPALLING

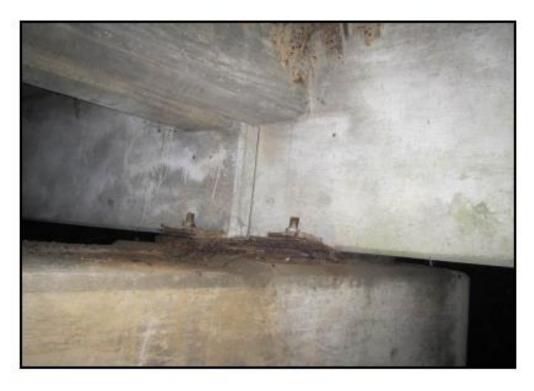
PHOTO 12 - 100% CORROSION ON BEARING PLATE, SPAN 2, BEAM 1 SHOWN

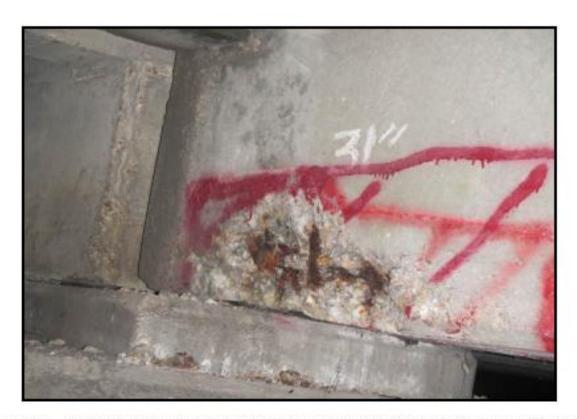
PHOTO 15 - SPAN 2, BEAM 4 AT PIER 1 SPALL WITH EXPOSED REBAR, 3'L X 1'H X 4"D

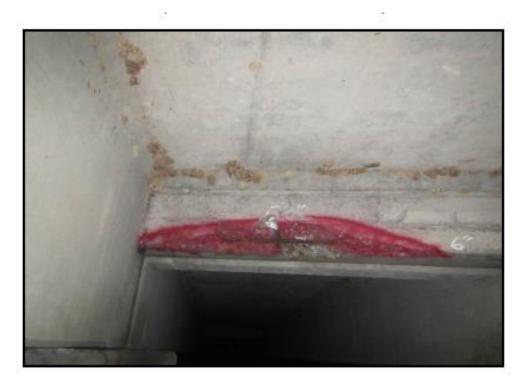
PHOTO 17 - SPAN 2, BAY 4 AT PIER 1 SPALL WITH EXPOSED REBAR, 60"L X 6"H X 4"D

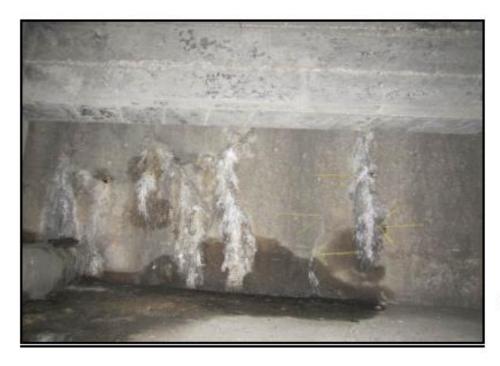
PHOTO 19 - NUMEROUS HAIRLINE VERTICAL CRACKS WITH CHEMICAL STAINS AT ABUTMENT B, BAY 5

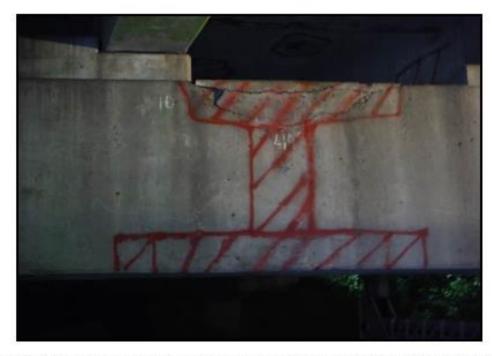
PHOTO 20 – PIER 1 SOUTH ELEVATION NEAR BEAM 5, 3 SF DELAMINATION NEAR TOP OF CAP WITH DEEP CRACKING

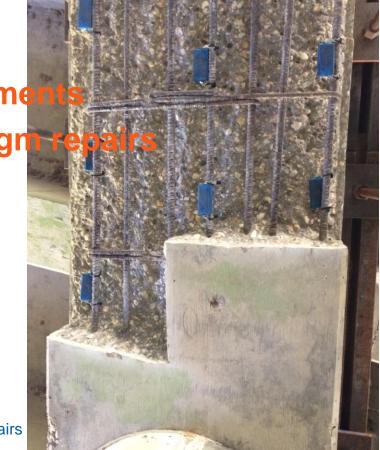
195 SBL over Potomac Cr. – Pier cap repairs

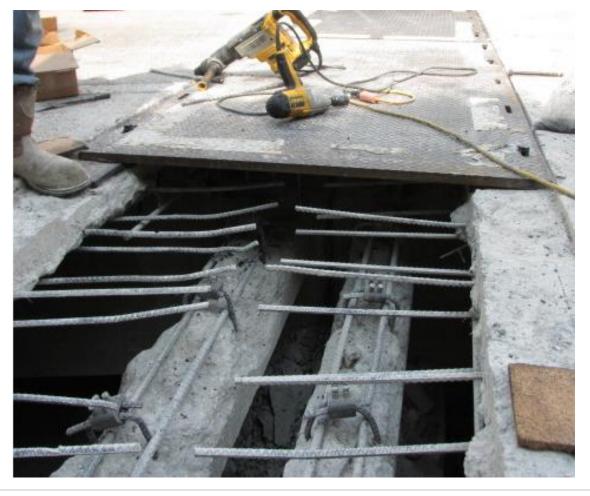
Joint Removal between Beams at Piers

SECTION D-D
JOINT REMOVAL DETAILS BETWEEN BEAMS AT PIERS

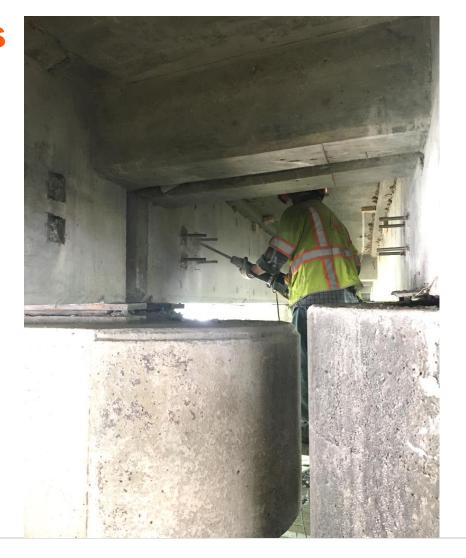
Joint Closure between Beams at Piers

JOINT CLOSURE DETAILS BETWEEN BEAMS AT PIERS

Temporary condition - after removing concrete portion	Permanent condition - after joint closure	
-Adequate interface shear friction is developed without 1'-7" portions of the joint closure	-Interface shear friction is adequate without the 2 shear stirrups eliminated in the link slab	
-No effect on cross section area channeling compressive arching action on shear-plane near support	285 285 285 285	2B3 2B4 Fascia 2B2 Interior
-Location of critical section for shear- d from internal support shift closer to internal face of support.	## ABI   2VI   310"   17'-0"   17'-0"   2VI   2VI   31'0"   33'-6"	2VI
-Development length of the longitudinal bent-up bars is adequate to develop their calculated tension	-Contribution of longitudinal bent-up bars in shear capacity is included.

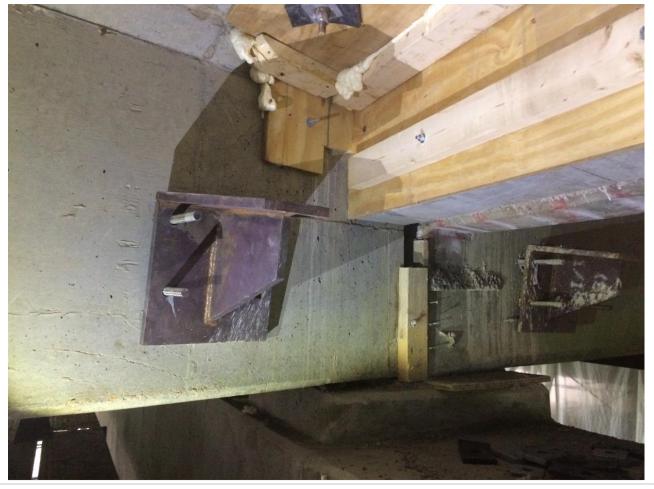
#### Joint Closure at Beams at Piers

SECTION G-G JOINT CLOSURE DETAILS AT BEAM AT PIERS
